BRAYTON CYCLE CAVITY RECEIVER DEVELOPMENT

QUARTERLY REPORT

JANUARY 1964 - MARCH 1964

(NASA Contract NAS 3-2779)

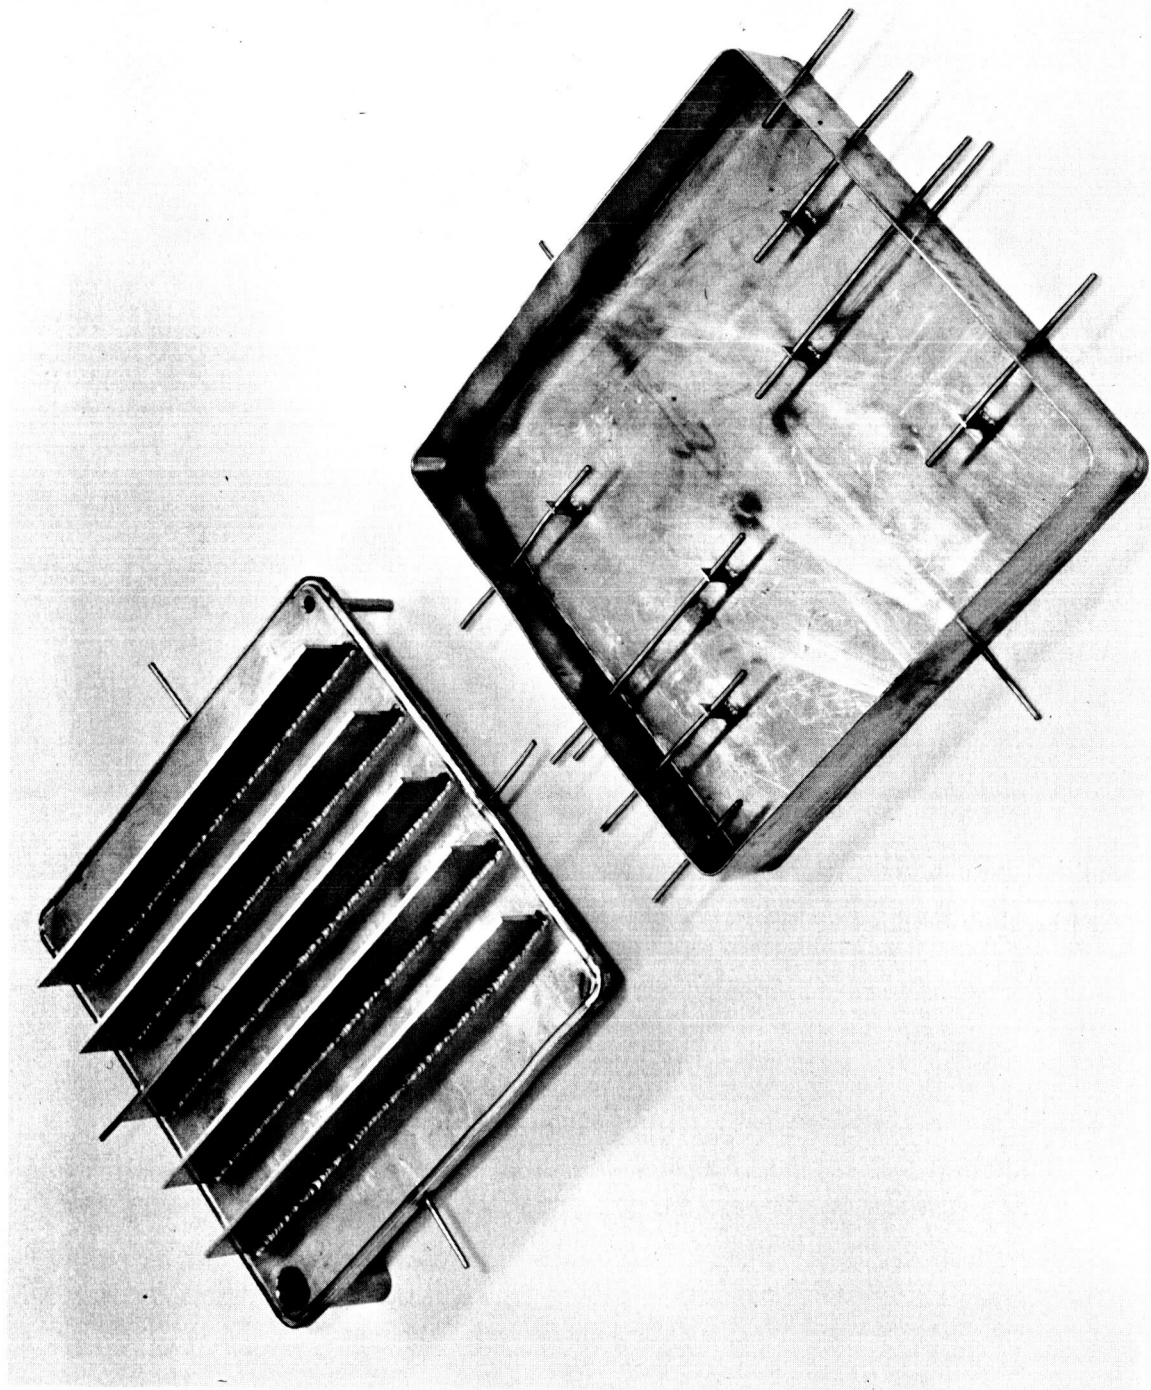
FIGURE 2

EXPLODED VIEW OF MODULE NO. 5 PRIOR
TO FINAL ASSEMBLY WELD

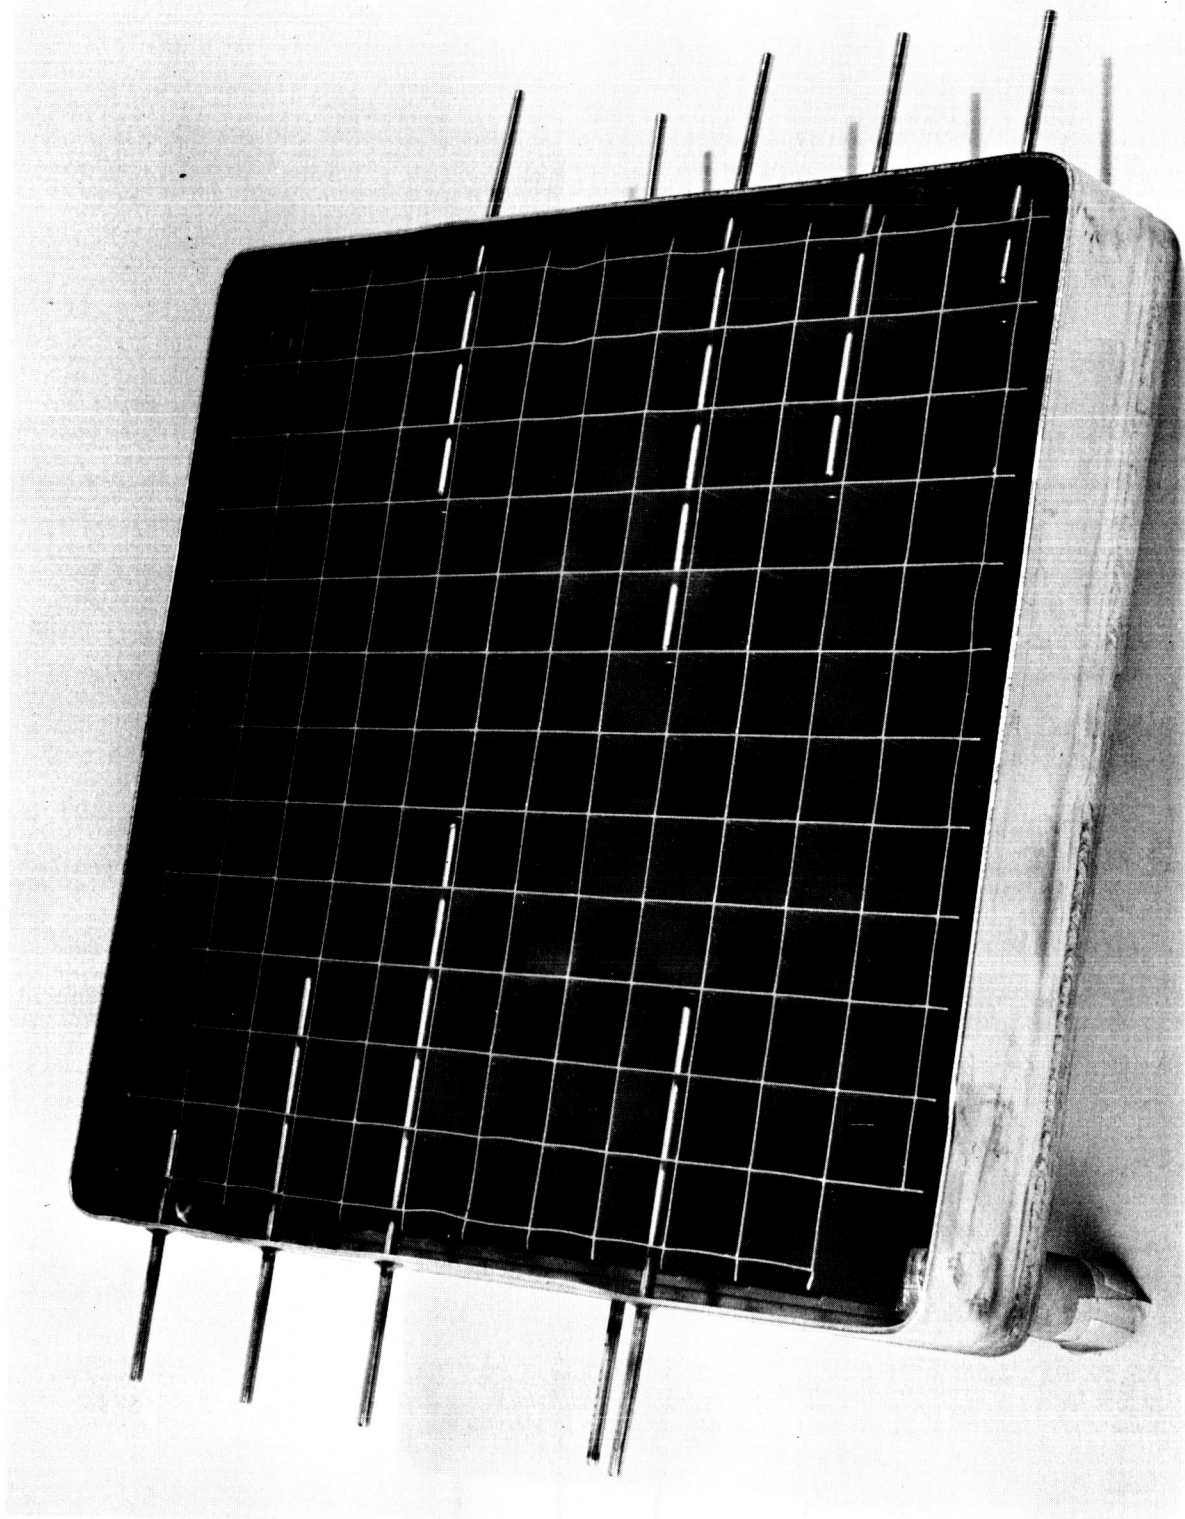
FIGURE 3

END VIEW OF MODULE NO. 6 PRIOR TO FINAL
ASSEMBLY WELD

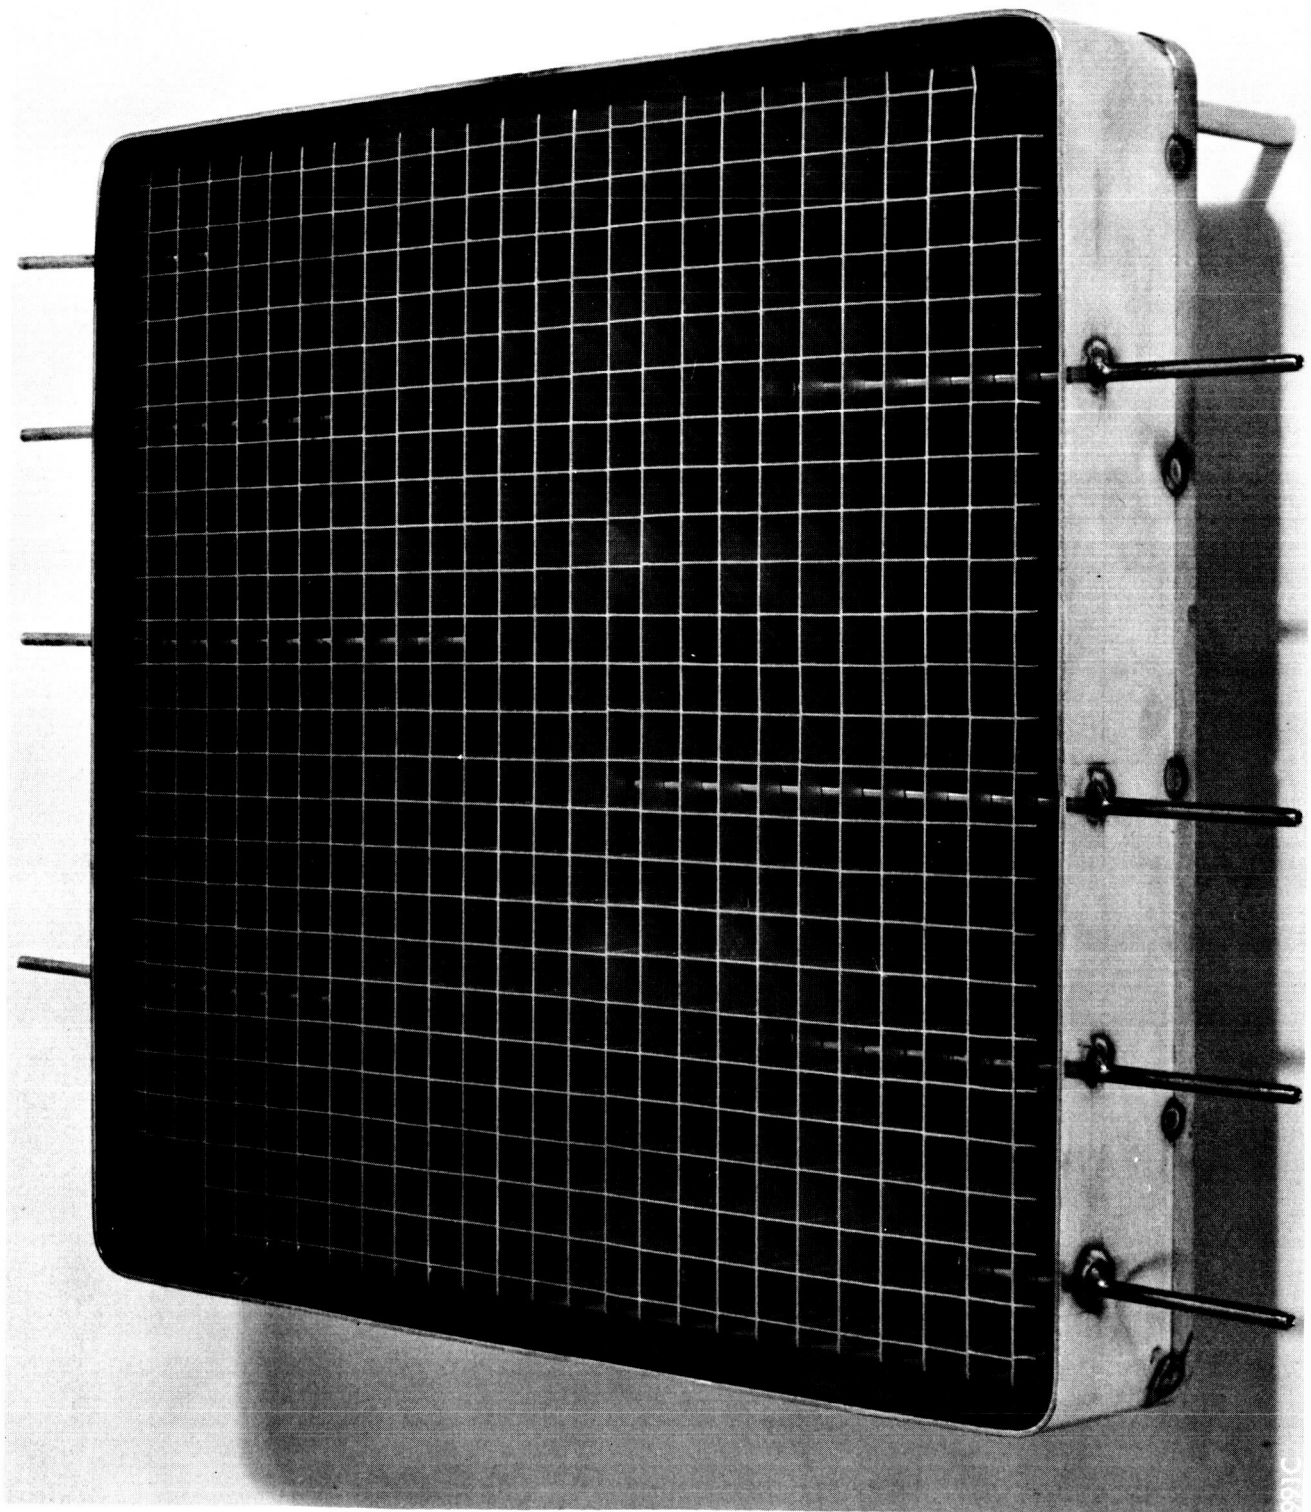
FIGURE 4

END VIEW OF MODULE NO. 7 PRIOR TO FINAL
ASSEMBLY WELD

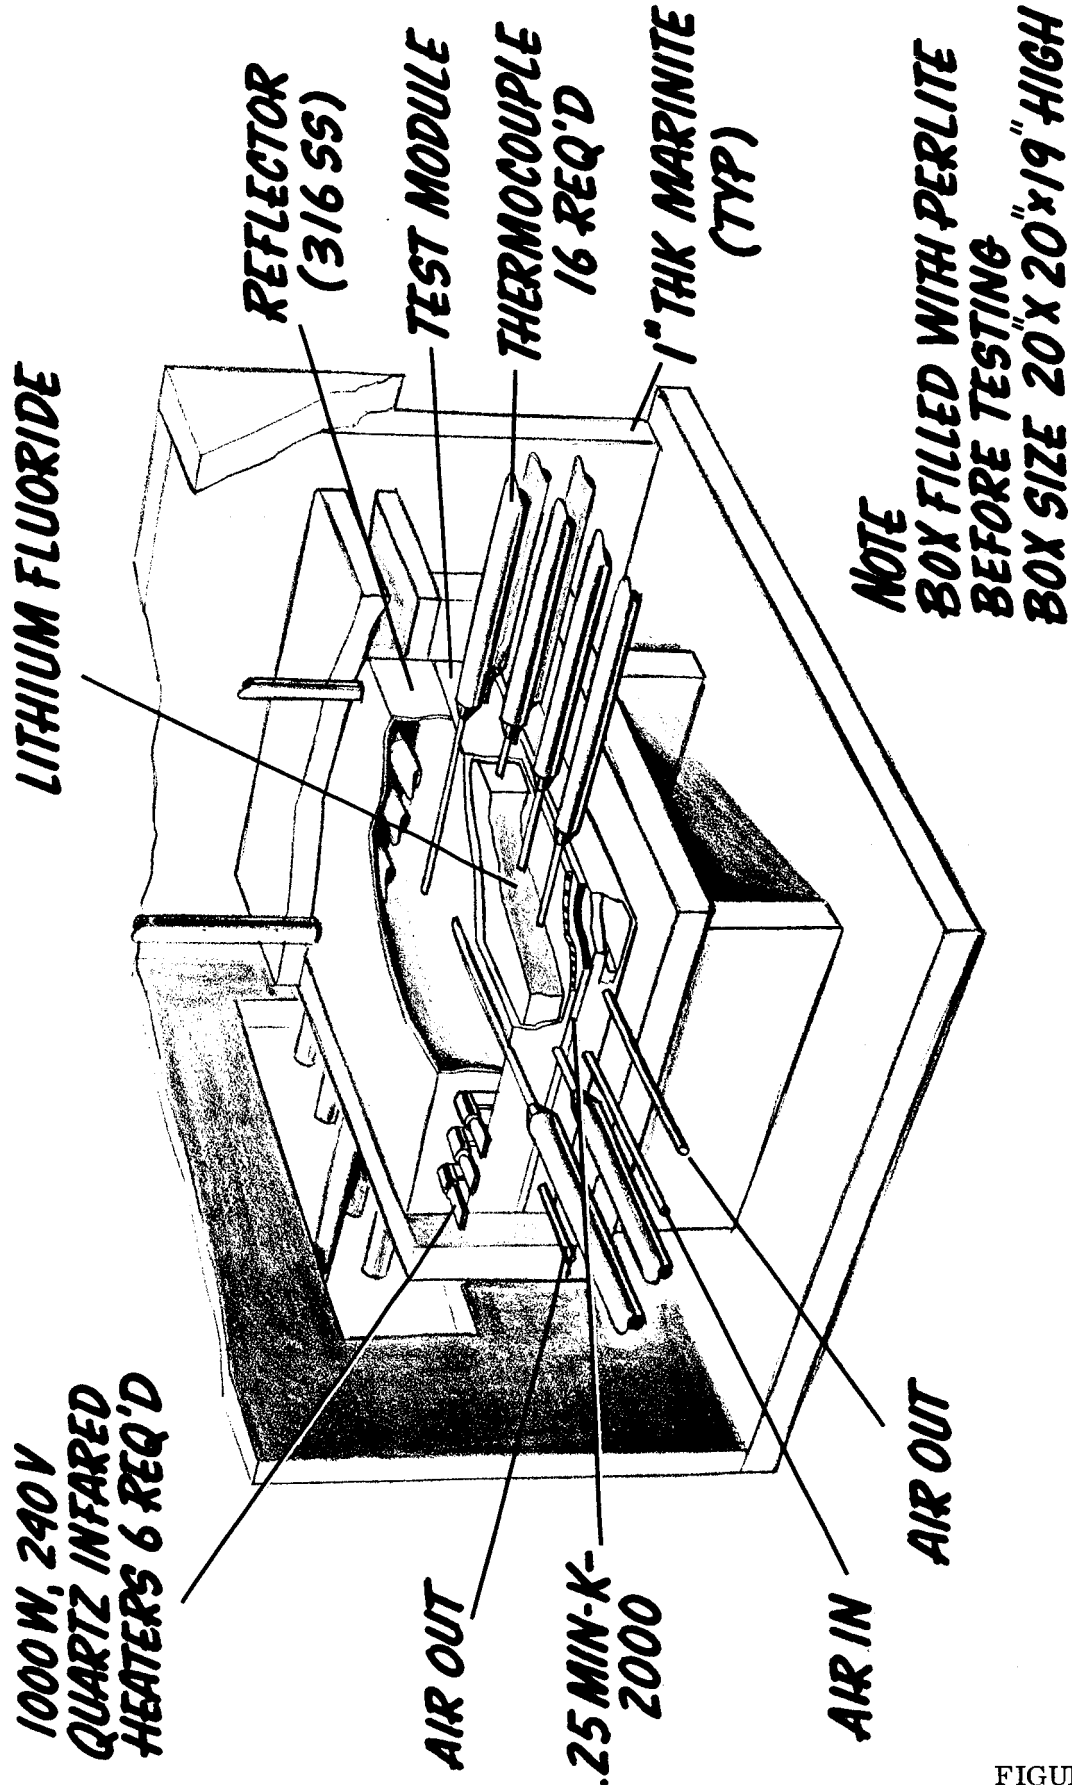
FIGURE 5

BRAYTON CYCLE TEST MODULE

An isometric cutaway view of the test bed is presented in Figure 5. A top view prior to filling the enclosure with perlite is shown in Figure 6. The heater leads are uncovered at one end and the thermocouple leads can be readily observed. The 1/4 in. O.D. argon bleed tube to the reflector and the 3/4 in. O.D. fill tube are plainly visible. Module number 1 is installed in the test fixture in Figure 6.

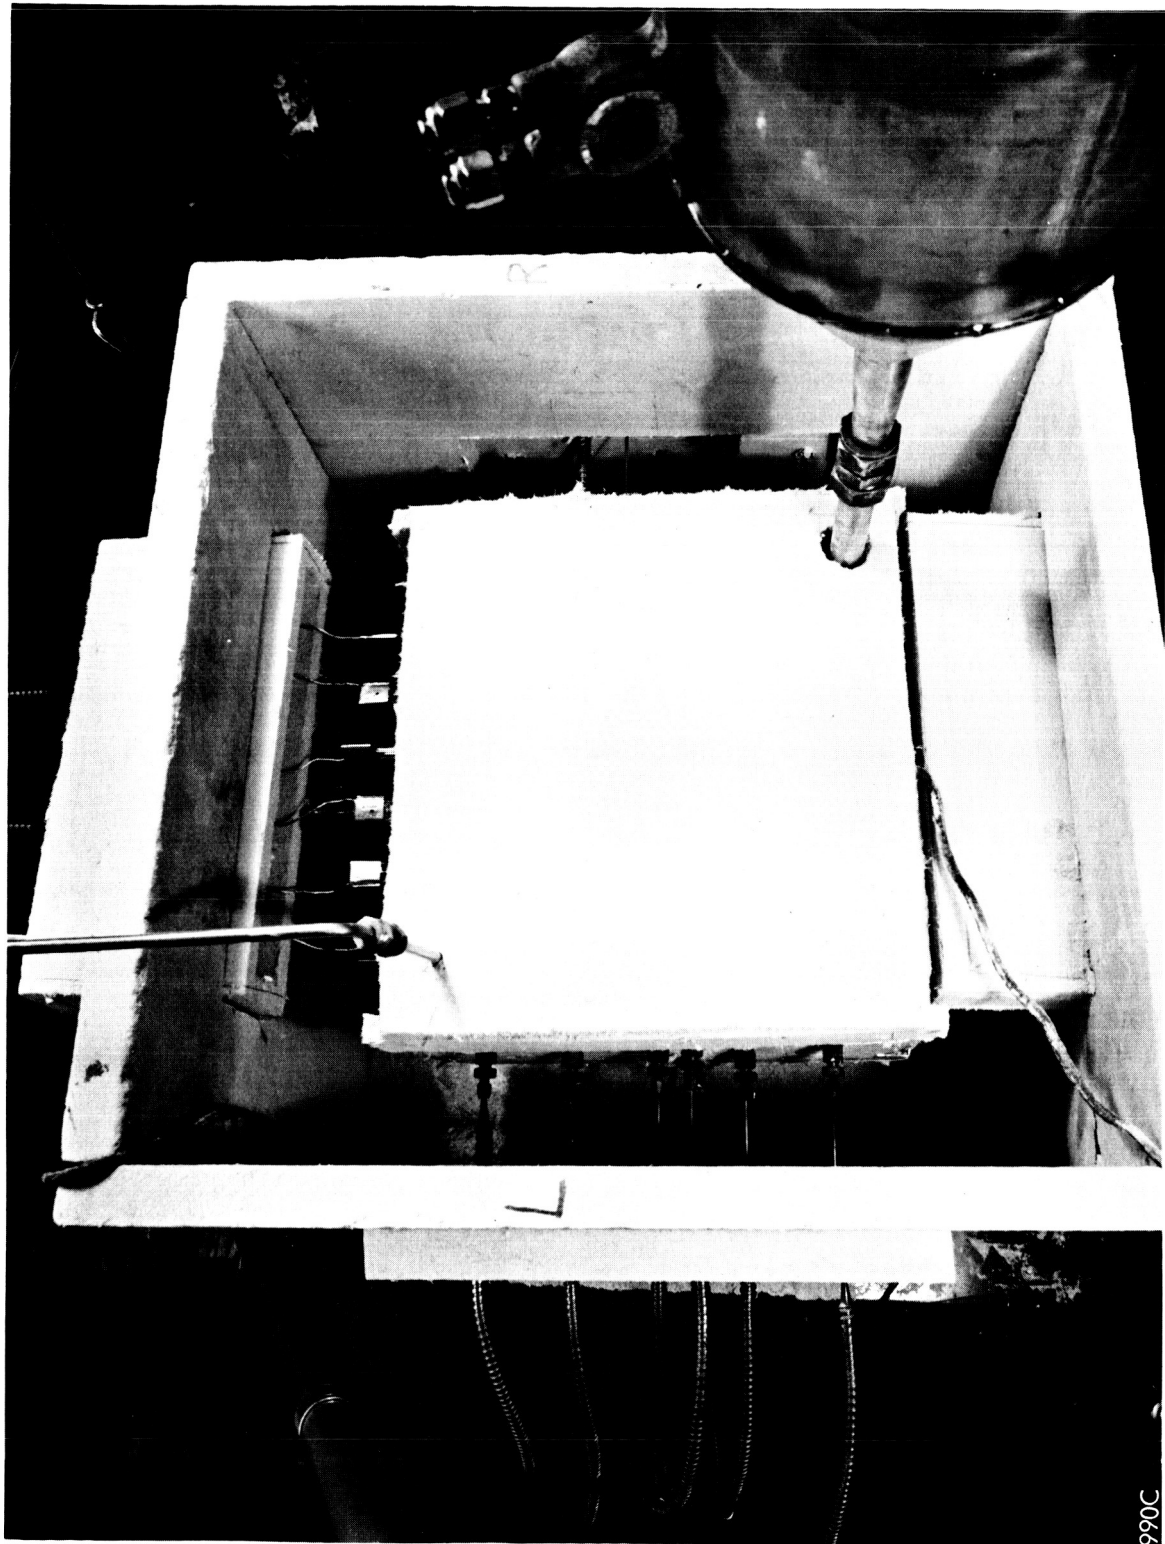
FIGURE 6

TOP VIEW OF TEST BED WITH HEATER ASSEMBLY
IN PLACE PRIOR TO FILLING WITH PERLITE

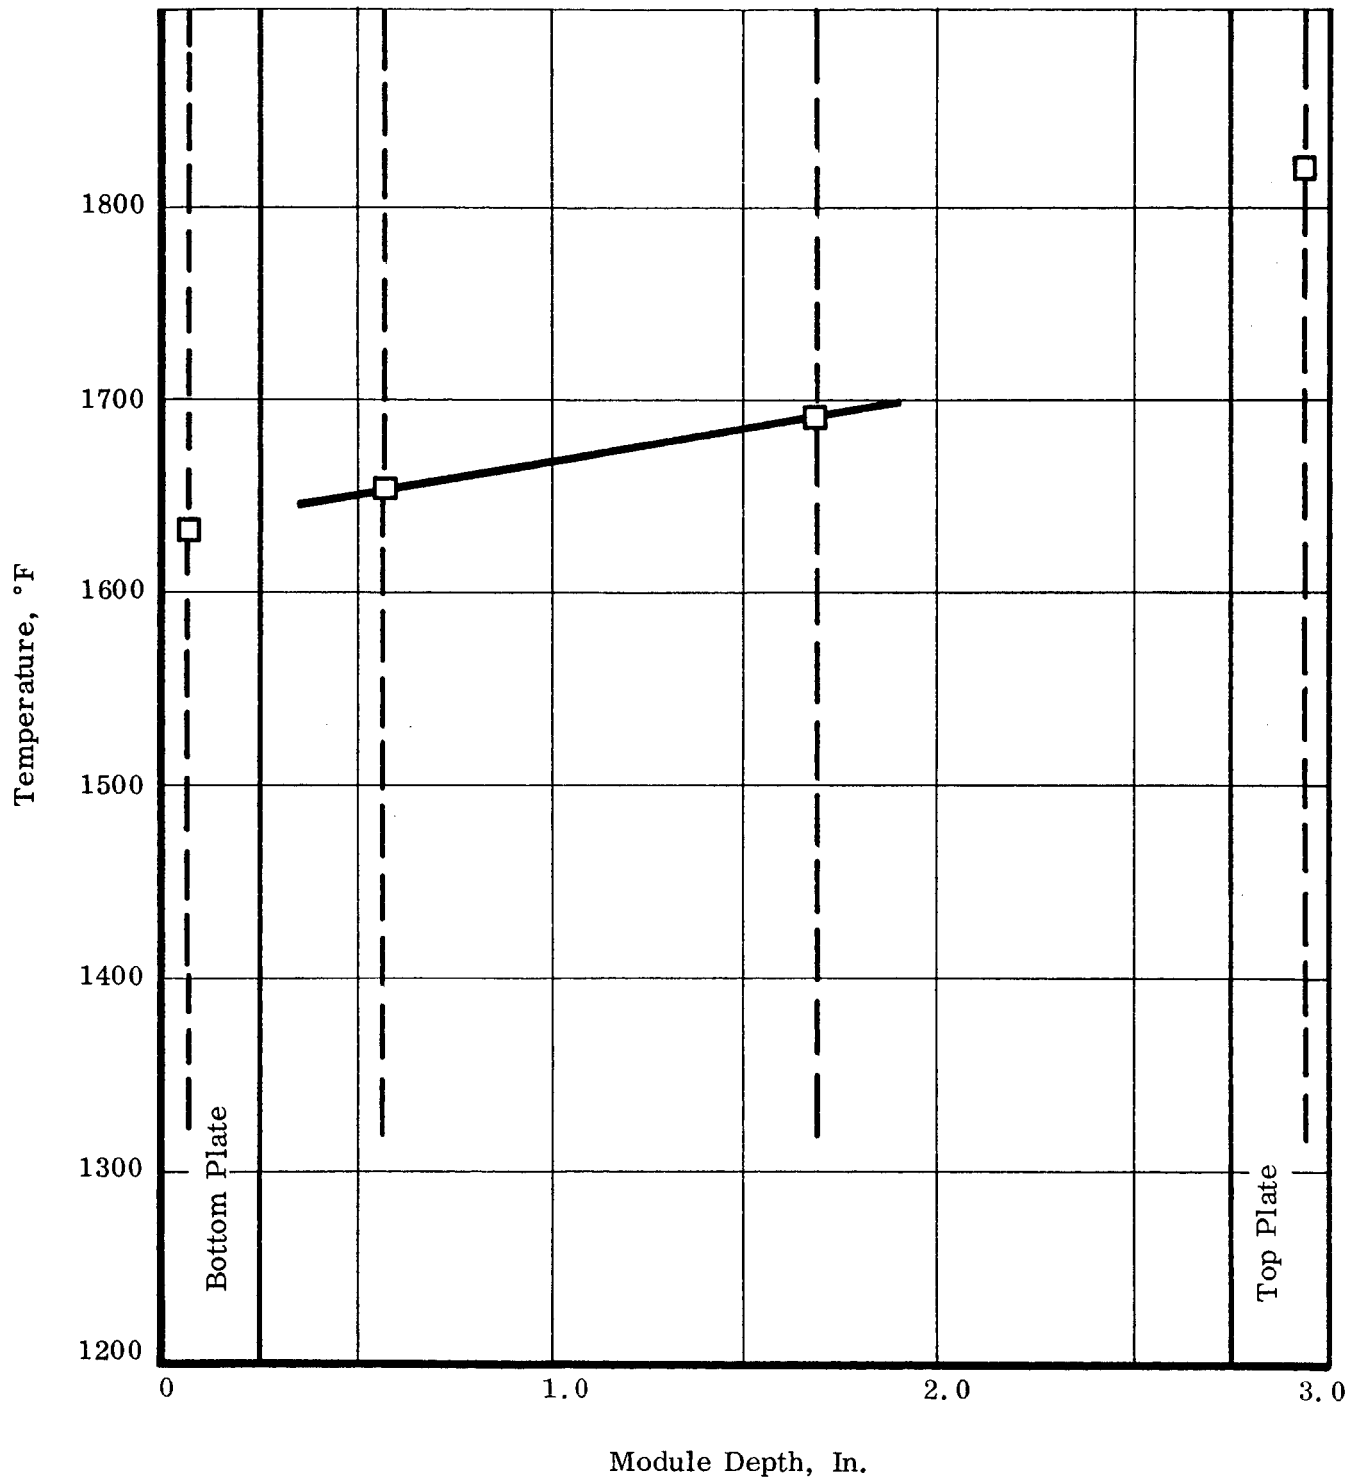
FIGURE 7

TYPICAL TEMPERATURES MEASURED IN LIQUID THERMAL CONDUCTIVITY TESTS

Typical temperature profiles are shown in Figure 7 for the liquid case and in Figure 8 for the solid case. An independent check of the temperature gradients which were employed in the calculation of the thermal conductivities was performed by a senior engineering specialist. He confirmed that the thermal gradients were acceptable. Unfortunately, the other half of the information needed to calculate the thermal conductivities, the heat flux, has not been confirmed by an independent appraisal. Thus, the values obtained are tentative only, and the data will be subjected to a continuing review to substantiate the heat flux calculation. It is preferred not to publish the data at this time until all elements have been checked and confirmed.

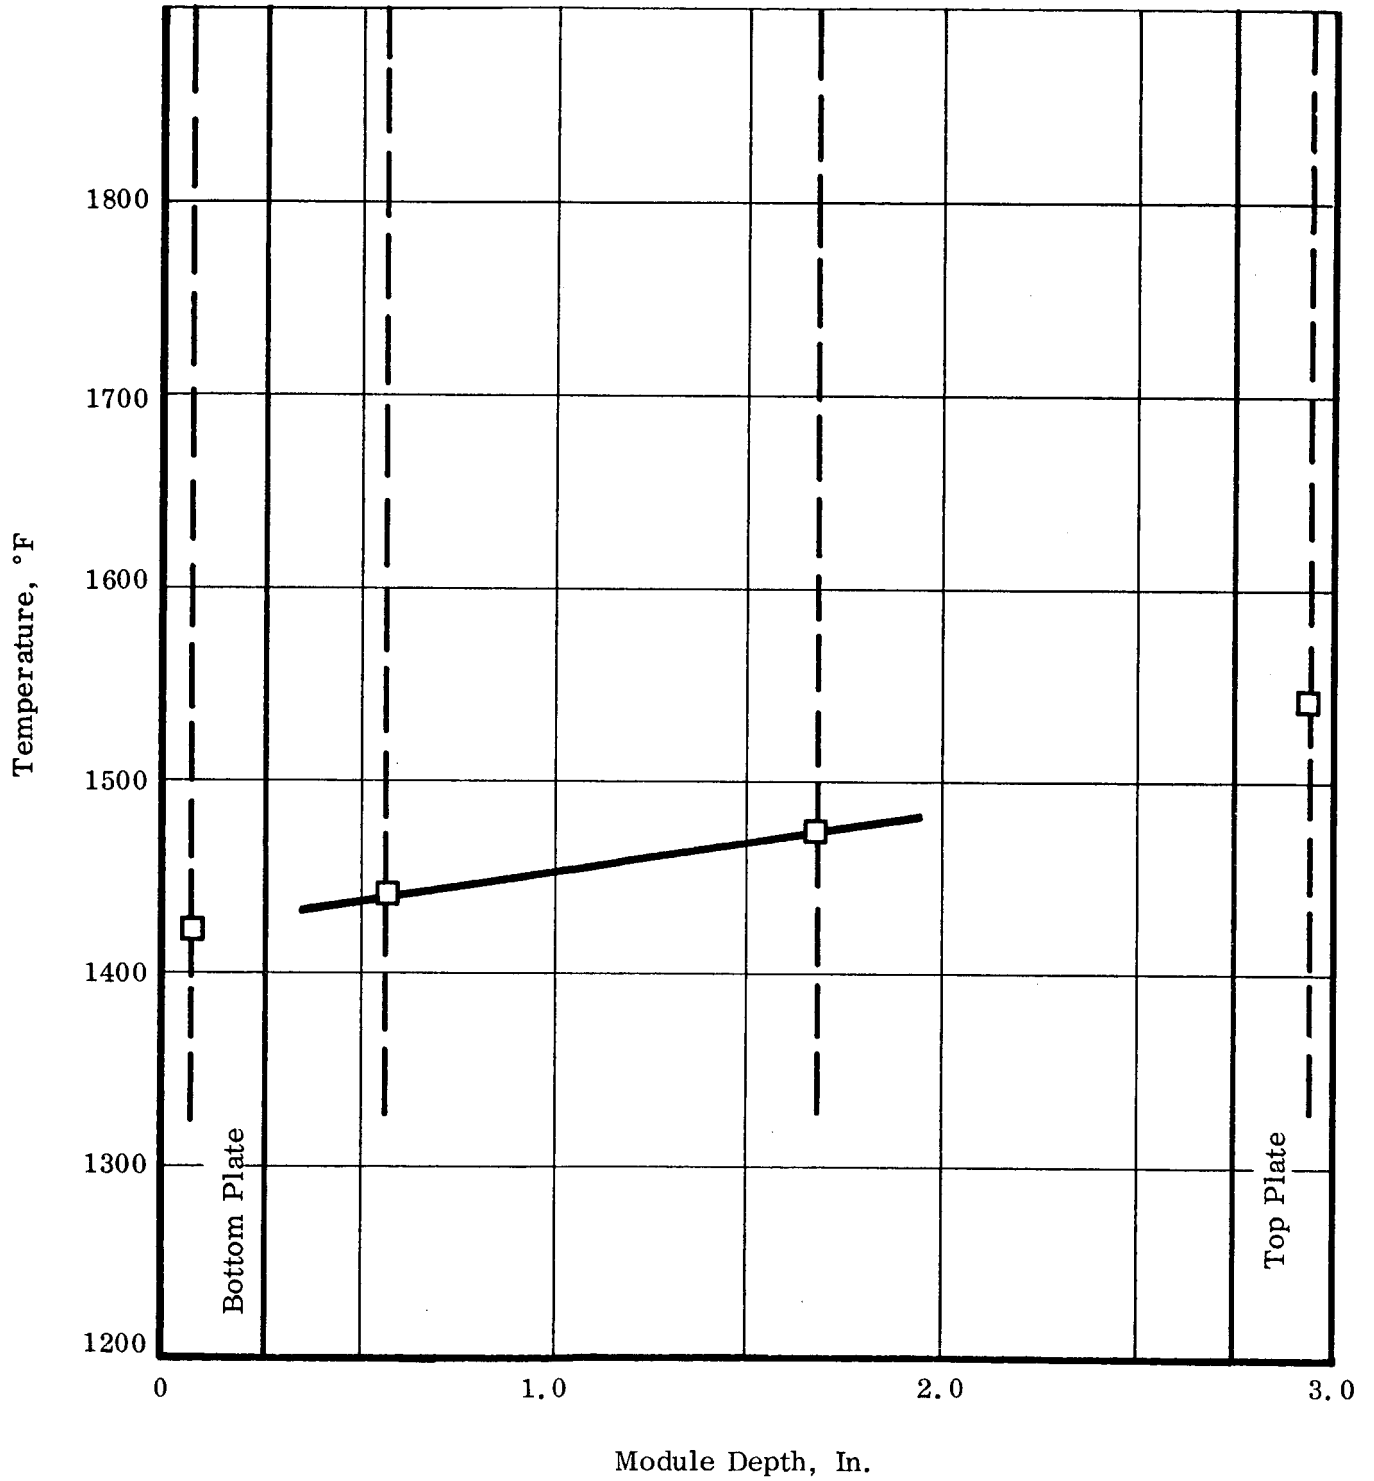
FIGURE 8

TYPICAL TEMPERATURES MEASURED IN SOLID THERMAL CONDUCTIVITY TESTS

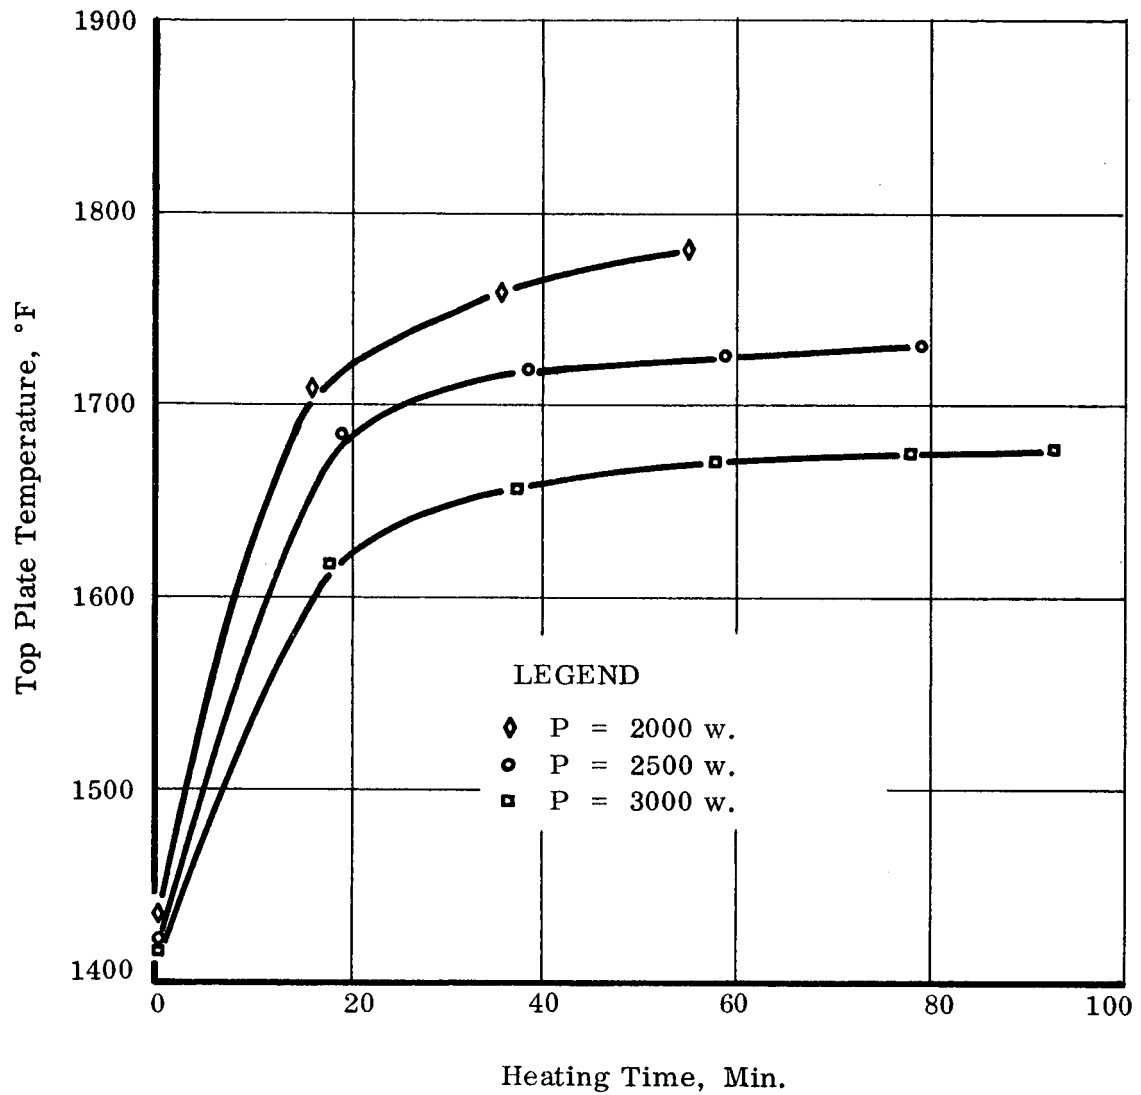
FIGURE 9

TYPICAL VARIATION OF TOP PLATE TEMPERATURE WITH HEATING TIME
AT SEVERAL POWER LEVELS - MODULE NO. 5

The top plate temperature variation with heating time at several power levels is presented in Figure 9 for module number 5. It can be observed that the time required to melt all of the lithium fluoride decreases with increasing heater power level. The top plate temperature is of interest since it represents the cavity surface temperature in the flight design. In the flight design, the cycle imposed is 60 minutes of sun time and a maximum of 38 minutes of shade time for the design of prime interest to NASA-Lewis. In the above 300 nautical mile orbit, all of the lithium fluoride must be melted at the end of the 60 minute heating time. Therefore, the all melted top plate temperature is representative of the maximum cavity surface temperature anticipated in the flight design at any given heat input flux level.

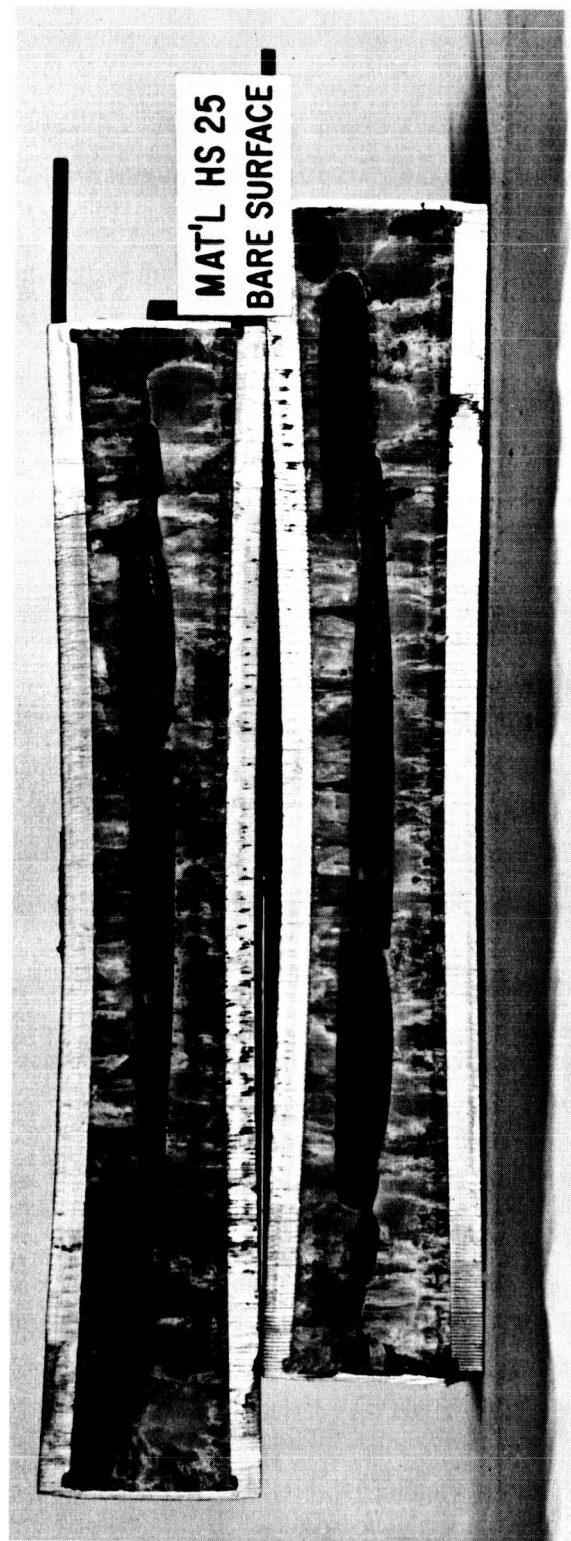
FIGURE 10

VIEW OF MODULE NO. 2 SECTIONED AFTER COMPLETION
OF TESTING

The cause of the difficulty with module number 2 was mentioned in the second quarterly progress report, ER-5736. A premature failure of a small bleed tube attached to the top plate permitted liquid lithium fluoride to escape. The fluoride attacked the top, sides and bottom of the module, the quartz heater elements and the Min-K insulation. Before refilling this module with lithium fluoride, it was necessary to machine new grooves in the top plate to house new thermocouple wells. This machining had to be performed on the assembled module. Obviously, the top plate was supported only at

edges and was essentially unsupported in the center. After the machining was completed, the test engineer noted that the top surface was no longer flat. It was decided at the time to refill with fluoride and attempt to obtain the proper data. Subsequent events have shown that it was impossible to get the correct data with the modified module.

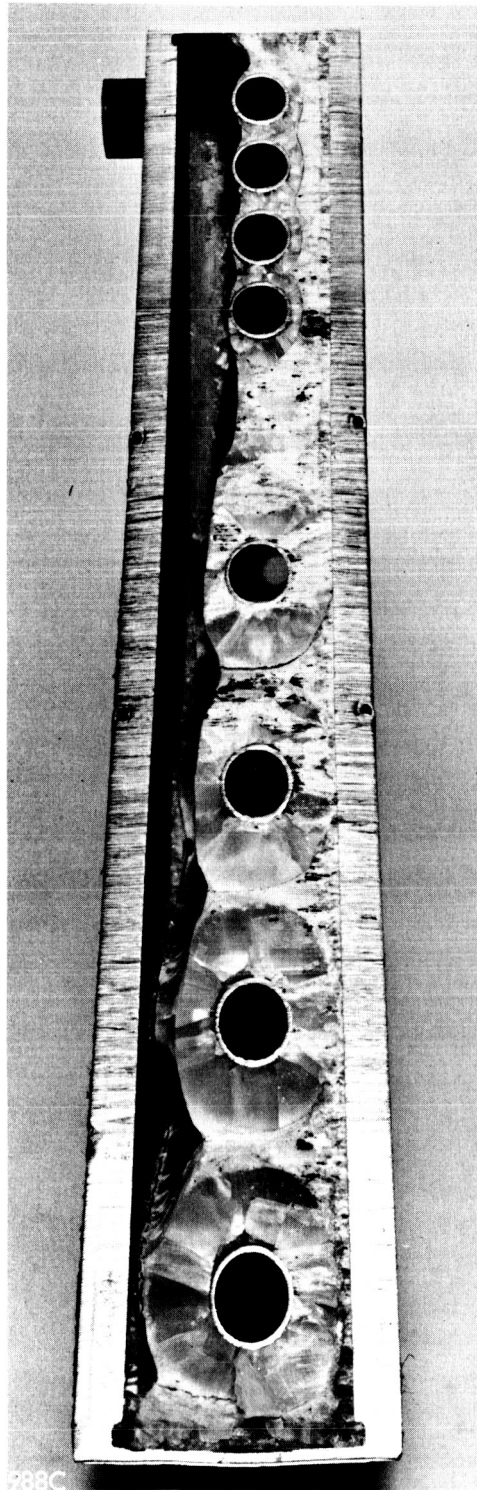
FIGURE 11

VIEW OF MODULE NO. 3 SECTIONED AFTER COMPLETION
OF TESTING

The top plate in Figure 11 can be observed to be flat. The HS 25 modules, except for module number 2 noted above, held up very well. The sectioned views of the 316 stainless steel modules indicated that the strength of the top plate was marginal at the test temperatures encountered. Thus, all future modules will be constructed of HS 25 alloy, or a similar high strength alloy.

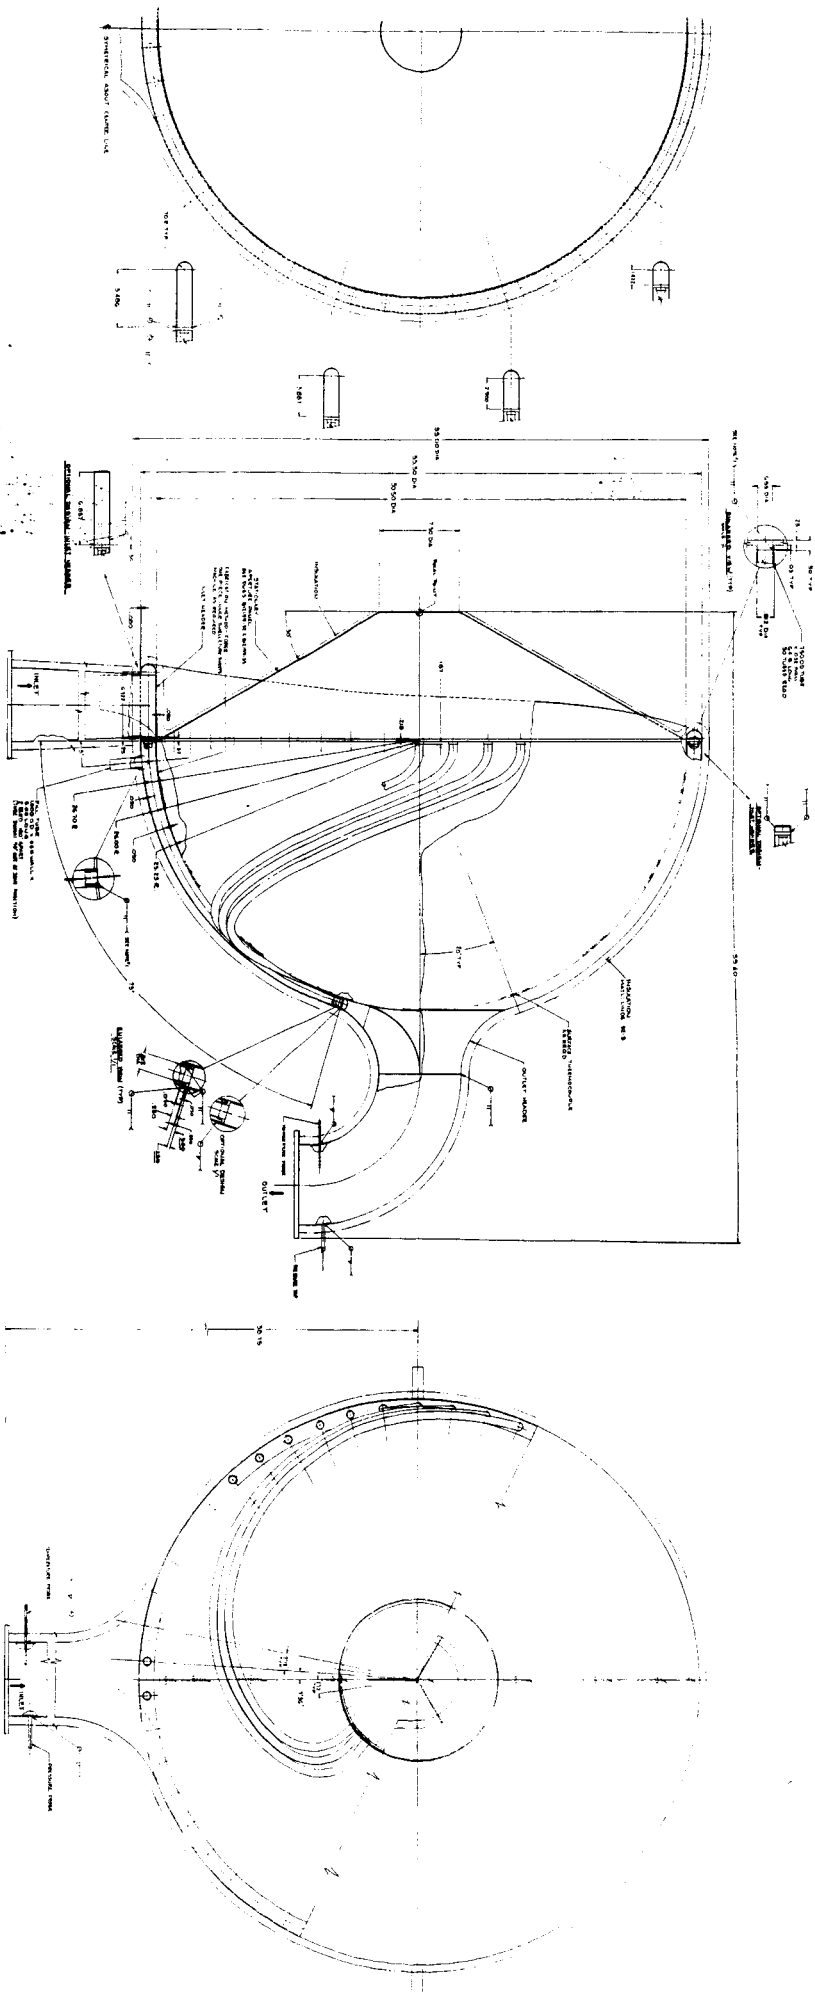
CAVITY RECEIVER 300 NM - 30 FOOT MIRROR
BRAYTON CYCLE

The layout of the basic container for the above combination is shown in Figure 12. The cavity surface temperature control and aperture closure device is a necessary and integral part of the cavity receiver component. The concept which was evolved from a study of the requirements is illustrated in Figure 13. The temperature control concept features the use of liquid metal contained within a closed system consisting of a temperature sensor and a bellows actuator. The vapor pressure of the liquid metal increases with temperature, and as the desired maximum temperature is approached, the vapor pressure produces a force sufficient to actuate the bellows. Linkages attached to the bellows open doors and increase the cavity reradiation losses, thus reducing the cavity surface temperature. A similar type of system is proposed for the aperture closure device. The results of the study and the concept in Figure 13 were presented to NASA on March 5 and 6. NASA technical personnel felt that the design shown was too complex and cumbersome. They suggested added effort should be performed to arrive at a design suitable for hardware development. A good start was made in this direction during March and early April, but the remaining contract funds are low and this effort must be stopped until additional funding is available.

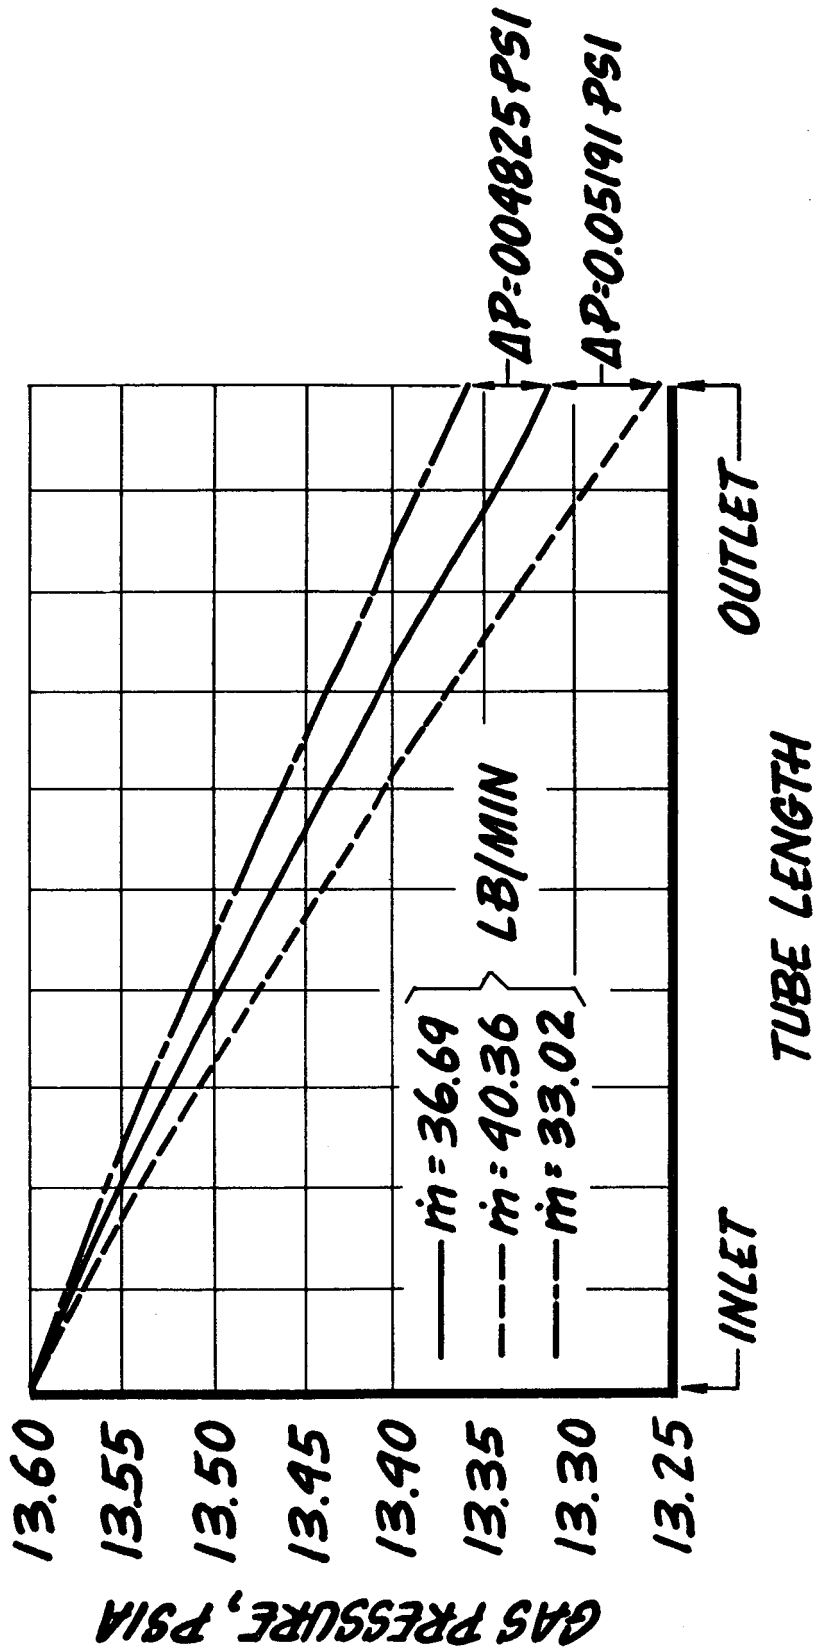
FIGURE 15

VARIATION OF GAS PRESSURE DROP WITH INSTANTANEOUS CHANGE OF 10% IN GAS FLOW RATE

Typical results for the off-design performance calculations are illustrated in Figures 14 and 15. Figure 14 shows the gas temperature variation encountered with an instantaneous change of ten (10) percent in the gas flow rate. Figure 15 shows the gas pressure variation under the same conditions.

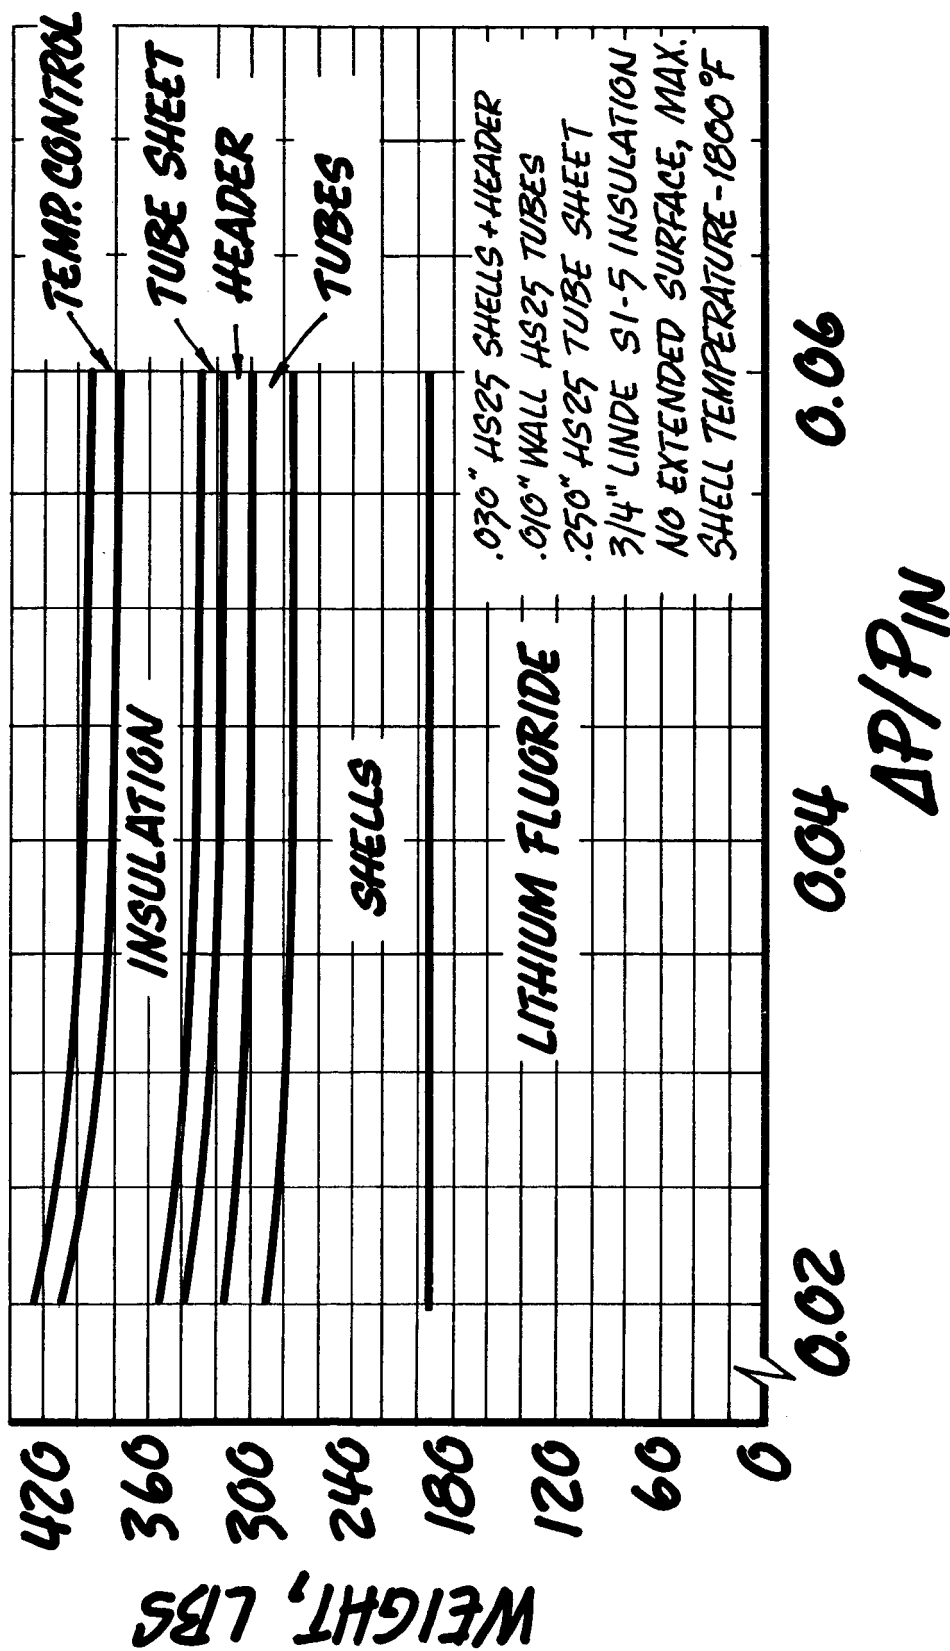
FIGURE 16

EFFECT OF $\Delta P/P_{IN}$ ON RECEIVER WEIGHT

300 N.M. ORBIT, 30 FOOT MIRROR

The design investigation of perhaps the most interest to NASA systems personnel was an examination of the effect a change in allowable gas pressure drop might have on the cavity receiver design. It can be observed from the list of conditions above that the allowable gas pressure drop in the heater had been set at approximately four (4) percent of the heater inlet pressure. NASA requested that designs based on allowable gas pressure drops of two, four and six percent of the heater inlet pressure be studied. The results are shown in Figure 16 for the combination of the 30-foot diameter collector and the 300 nautical mile orbit. It can be observed from Figure 16 that the estimated weight for the two percent design is about 30 pounds more than the four percent design, but no further weight further reduction is achieved at six percent. One requirement for the two percent design is a larger cavity diameter and thus a larger amount of collector blockage. Despite this disadvantage, NASA is anxious to pursue the two percent design to a full layout. If no additional disadvantages are uncovered, the two percent design should be very attractive to the systems designers in that the lowered pressure drop permits a tolerance for off-design performance on the part of the turbomachinery.
